Manhole Inspection Summary

Manhole # S45II_057MH

Record Plat: **45II** Node: **057** Status: **Found**

Location Address: **Oliver St**

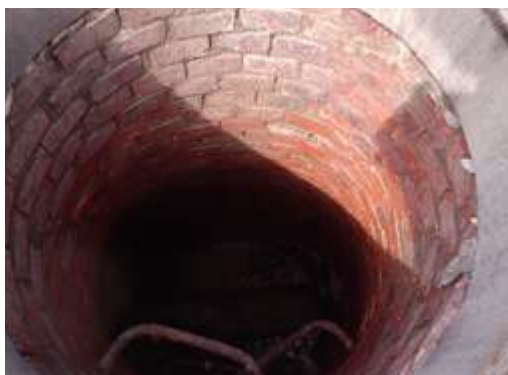
Defect 1

infiltration

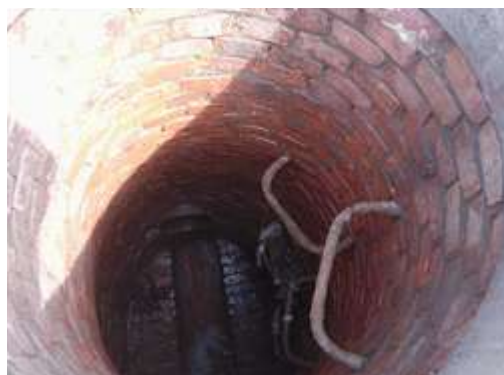
Defect 2

Infiltration

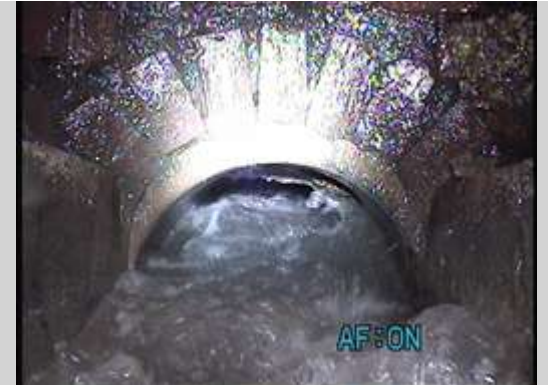
12 O'Clock Outflow

12 in. Circular Gravity Sewer
Pipe Out @ 12 O'Clock

Pipe Height: **12** (in.) Rod and Bar (Angled)
Pipe Material: **Clay** ☐ Pipe Lined
Invert Depth: **12.25** (ft.) Flow Characteristics: **Turbulent**
Deposits: ☒ None ☐ Mud ☐ Sludge ☐ Debris ☐ Grease
Silt Depth: (in.) Deposits Extent:
Infiltration: **None** Pipe Seal Cond: **Sound**

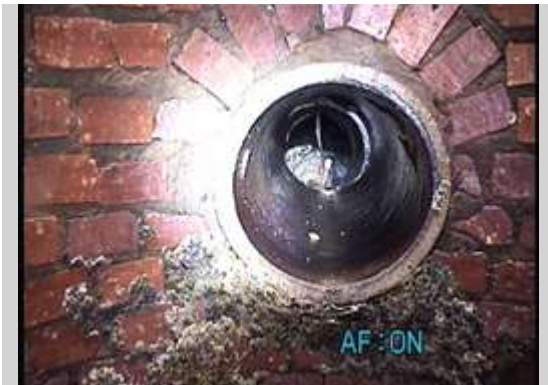
6 O'Clock Inflow

10 in. Circular Gravity Sewer
Pipe In @ 6 O'Clock

Drop In @ 6 O'Clock

Pipe Height: **10.8** (in.) Rod and Bar (Angled)
Pipe Material: **Clay** ☐ Pipe Lined
Invert Depth: **8.80** (ft.) Flow Characteristics: **Turbulent**
Deposits: ☒ None ☐ Mud ☐ Sludge ☐ Debris ☐ Grease
Silt Depth: (in.) Deposits Extent:
Infiltration: **None** Pipe Seal Cond: **Sound**

Drop: **Inside** Rod and Bar
Angled: **Yes** Reading: **10.95** (ft.)
Inv Depth: **11.95** (ft.)

Drop Condition: **Open**
